SUBJ: RCRA Compliance Evaluation Inspection
Alabama and Gulf Coast Railway
EPA ID # ALR000046706

RCRA Inspection Report

ALABAMA AND GULF COAST RAILWAY

COMPLIANCE EVALUATION INSPECTION PHOTOGRAPHS

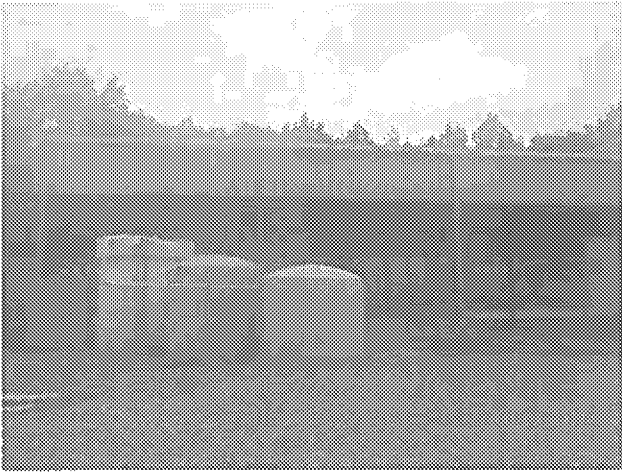
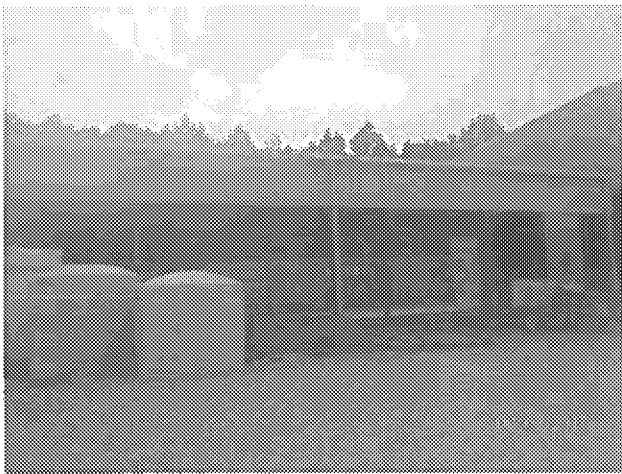
The inspectors observed three 2,500-gallon waste water tanks and an underground sump tank covered in plastic to prevent rain runoff. (Pictures 1, 2, 7, 8, and 9). The tanks receive waste water from the Railcar Wash Rack and the waste water is considered to be non-hazardous. The aboveground tanks were observed labeled and closed. Mr. Salter stated that AGR was planning to replace the tanks in the future.

Picture 1 -- Wash Rack, Waste Water Tanks and Sump Tank

Picture 2 -- Wash Rack, Waste Water Tanks and Sump Tank

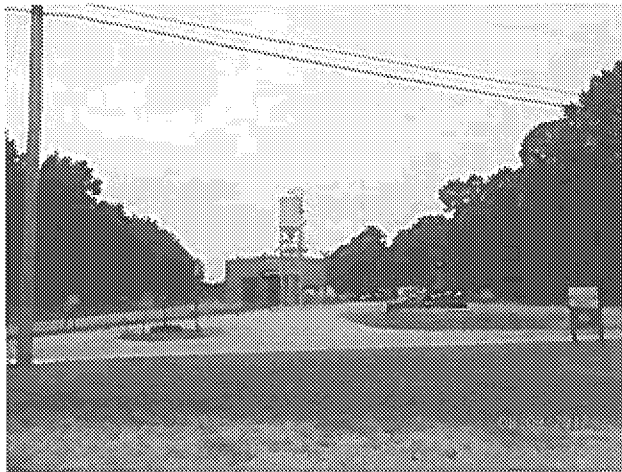
Picture 3 -- AGR Overview

This facility has been in operation at this location since 1997 as AGR, previously as Burlington Northern Railroad in 1980. The facility is located between 5-10 acres with a railcar wash rack, three waste water tanks, an underground sump tank, a two-bay repair shop, and outside lay areas for engineering and onsite contractor Progressive Rail (Pictures 3-4). The facility has 22 employees, and operates 8 hours a day, five days a week.

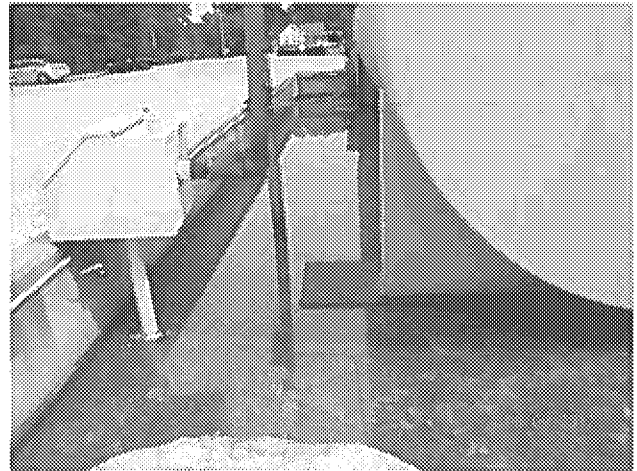
Beside the wash rack was were two fuel tanks inside secondary containment (Pictures 5-6). Due to the recent rains, the secondary containment was filled with water, algae and oily residue. The inspectors recommended cleaning out the secondary containment.

Picture 5 -- Used oil secondary containment filled rainwater

Picture 6 -- Used oil secondary containment filled rainwater

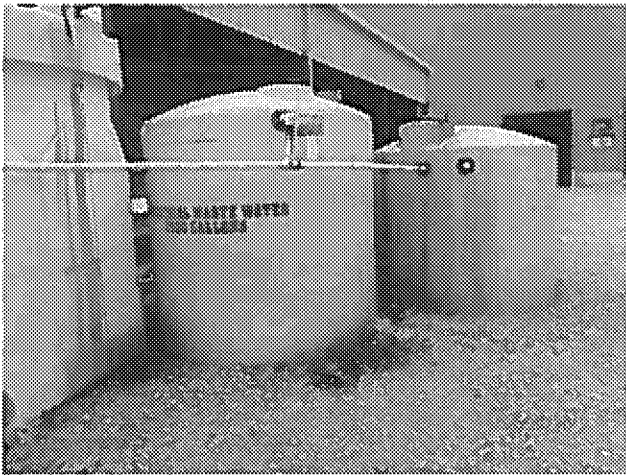
Picture 9 -- Waste water tanks

Picture 7 -- Waste Water Tanks

The inspectors asked if the waste water had a waste determination analysis, and was told by Mr. Salter the water has never been tested. The inspectors expressed concern that the Steam Cleaner Concentrate used to clean the railcar was corrosive, and that the waste water should be tested for hazardous characteristics.

Pursuant to ADEM Admin. Code r. 335-14-3-.01(2) [40 C.F.R. § 262.11], a person who generates a solid waste, as defined in ADEM Admin. Code r. 335-14-2-.01(2) [40 C.F.R. § 261.2], must determine if that waste is a hazardous waste following the methods articulated in ADEM Admin. Code r. 335-14-3-.01(2) [40 C.F.R. § 262.11].

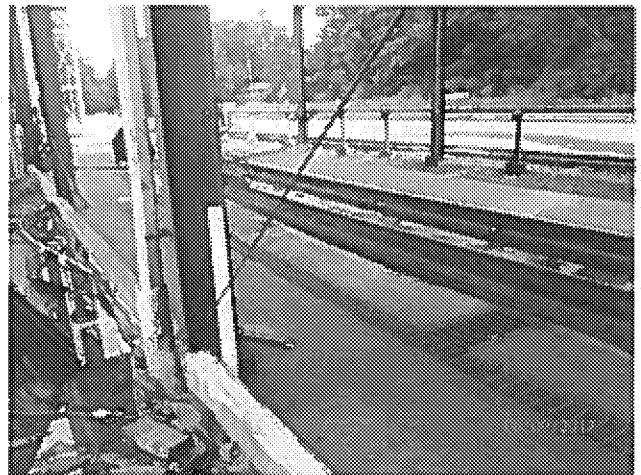
The inspectors observed a single rail line wash rack under an overhang (Pictures 10-11). The wash rack is used to clean the AGR railcars. Steam Cleaner Concentrate, manufactured by Covington Cleaner and Equipment, is used for the railcar cleaning (Picture 46). The inspectors noted that the concentrate was labeled as corrosive.

Picture 10 -- Railcar Wash Rack

Picture 11 -- Railcar Wash Rack

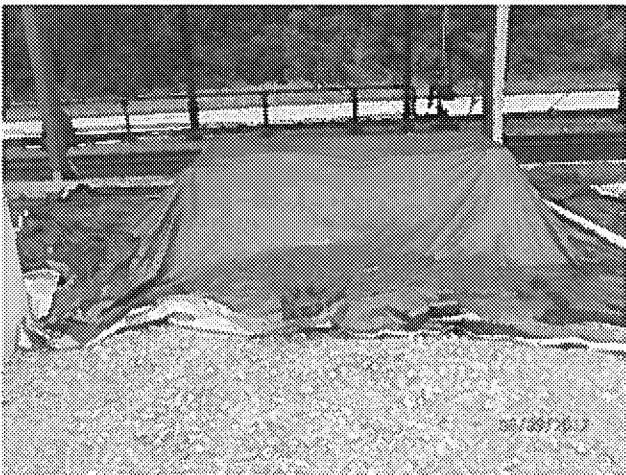
Picture 8 -- Underground sump tank

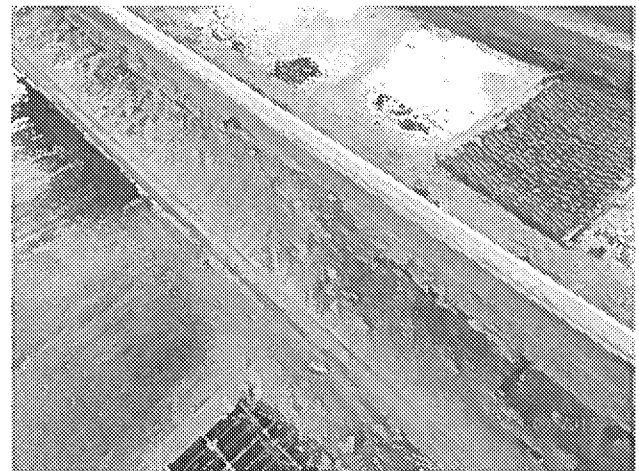
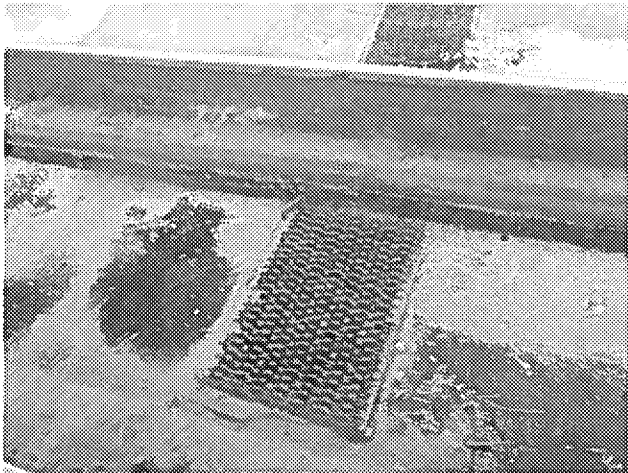
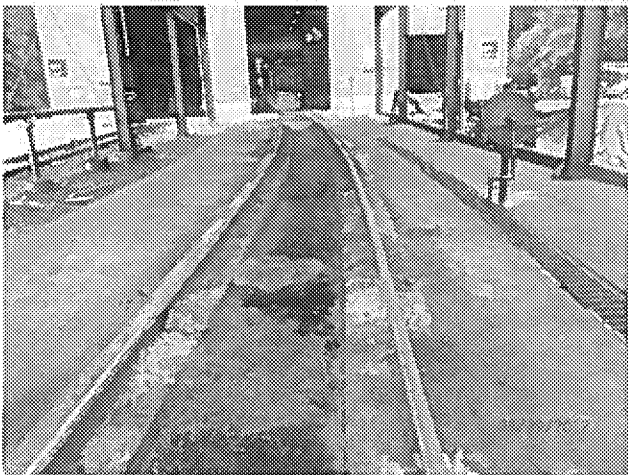
The ground around the wash rack rail was covered in oily sludge from the oil hose and the sand applied to the railcar (Pictures 15-17). Underneath the tracks is a grated drain that drains to the underground sump tank (Pictures 12-14). At the time of the inspection, the grated drain was filled with spilled oil and sand. Mr. Salter explained that the wash rack area is cleaned every three weeks.

Picture 15 -- Used oil/grease residue on the ground of the
Wash Rack

Picture 16 -- Used oil/grease residue on the ground of the Wash Rack

Picture 17 -- Used oil/grease residue/sand on the ground of the Wash Rack

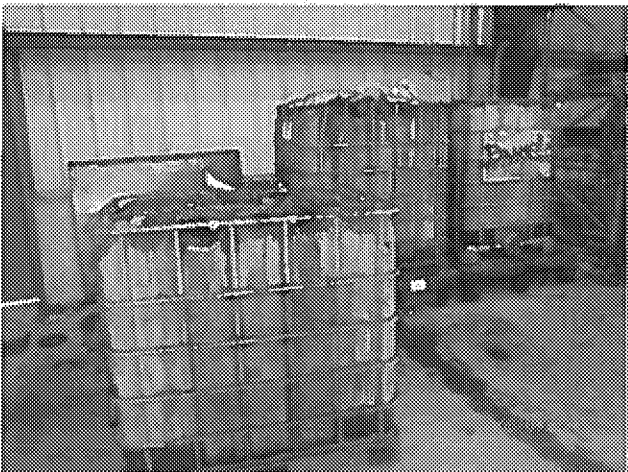
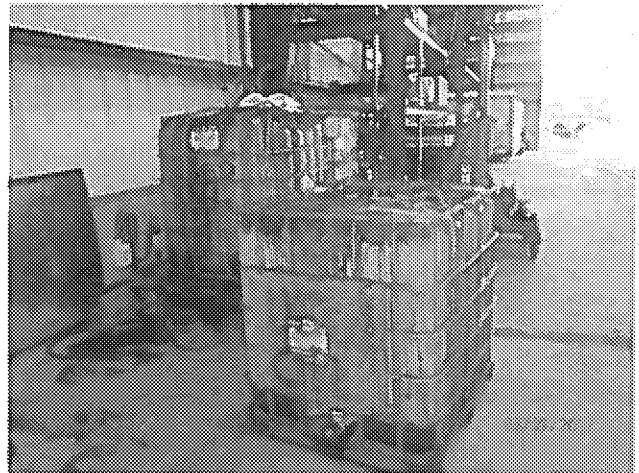
- Two 300-gallon used oil totes that were labeled "Used Oil" and closed. One of the totes did not sit on secondary containment and was full, the second tote was on secondary containment and was half full (Pictures 18-19).

Picture 18 -- Used Oil Totes (3)

Picture 19 -- Used Oil Totes (3)

Pursuant to ADEM Admin. Code r. 335-14-17-.03 (4)(a) [40 C.F.R. § 279.22(a)], used oil generators shall not store used oil in units other than tanks, containers, or units subject to regulation under parts 264 or 265 of this chapter.

Pursuant to ADEM Admin. Code r. 335-14-17-.03 (4)(a) 1., a container holding used oil must always be closed during storage, except when it is necessary to add or remove used oil.

Pursuant to ADEM Admin. Code r. 335-14-17-.03(4)(c)1. [40 C.F.R. § 279.22(c)(1)], containers and aboveground tanks used to store used oil at generator facilities must be labeled or marked clearly with the words "Used Oil."

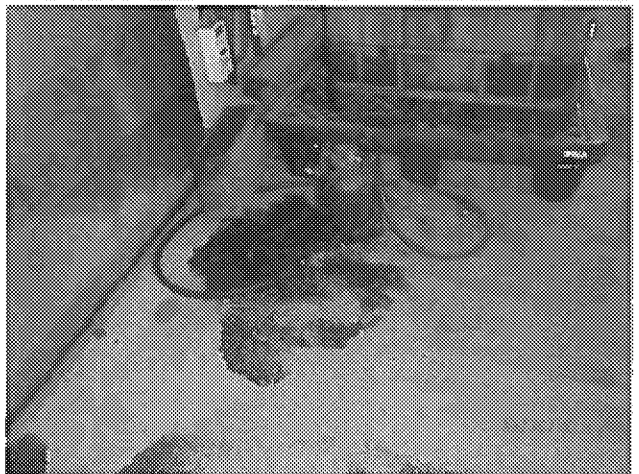
- The floor around the three 300-gallon totes was covered in spilled oil and absorbent, and had not been cleaned up (Picture 21).
- A 5-gallon container of used absorbent rags that was not closed or labeled "Used Oil" (Picture 22). Mr. Salter stated that the rags would be added to the yellow used oil totes.

Picture 21 -- Used oil and absorbent on the ground

Pursuant to ADEM Admin. Code r. 335-14-17-.03(4)(d) [40 C.F.R. § 279.22(d)], upon detection of a release of used oil to the environment, the facility must clean up and manage properly the released used oil and other materials.

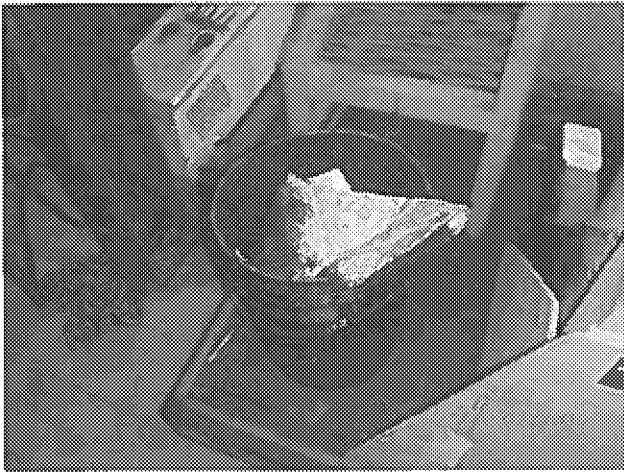
Picture 22 – Container of used absorbent rags

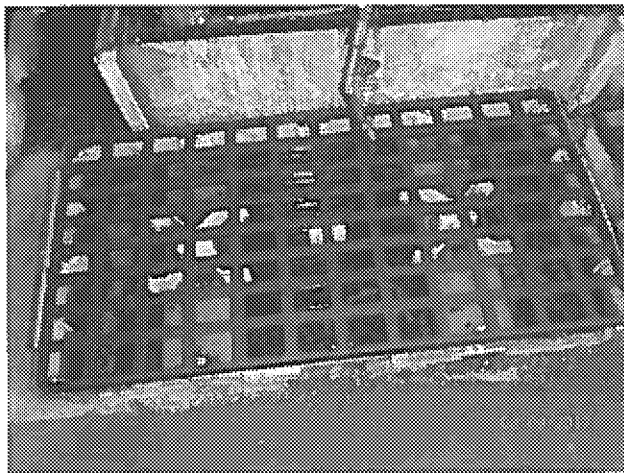
- Two secondary containments in front of the 300-gallon totes were filled with used oil and had not been labeled or cleaned out (Pictures 23-24).
- Two secondary containments underneath oil totes were filled with released oil that was not usable (Pictures 25-27). The containments were not labeled or cleaned out.

Picture 23 – Secondary containment filled with spilled oil

Picture 24 – Secondary containment filled with spilled oil

On August 18, 2017, Mr. Salter provided via email photographs and the following statement "I had the yellow totes replaced with three totes with tops and label used oil. I had damage used oil tote that was not label empty and cleaned out to be replace. The secondary containment has been cleaned and label. The used oil that had leak on the floor around totes has been clean up. We are checking on how to disposed of the old paint cans. The waste water sample has been sent for a determination. I have attach pictures. Joni Willhite is checking on the form 8700-12 and I will update you."

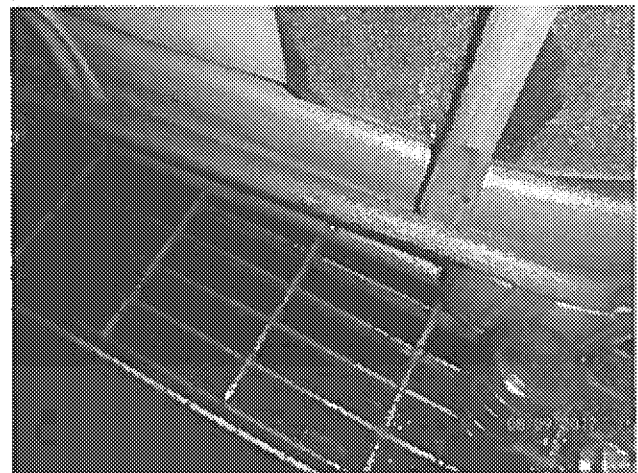
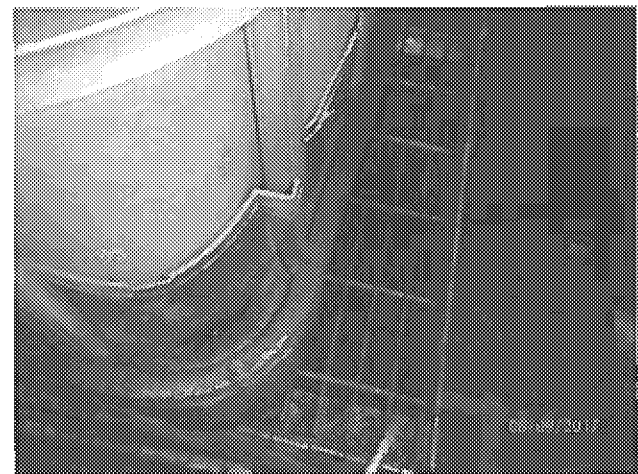
- The floor around the product oil totes was covered in spilled oil and absorbent, and had not been cleaned up (Picture 25).
- The pit area underneath the locomotives being maintained drains directly the underground sump tank.

Picture 25 – Secondary containment filled with spilled oil and used oil release/absorbent on the ground

Picture 26 – Secondary containment filled with spilled oil

Picture 27 – Secondary containment filled with spilled oil

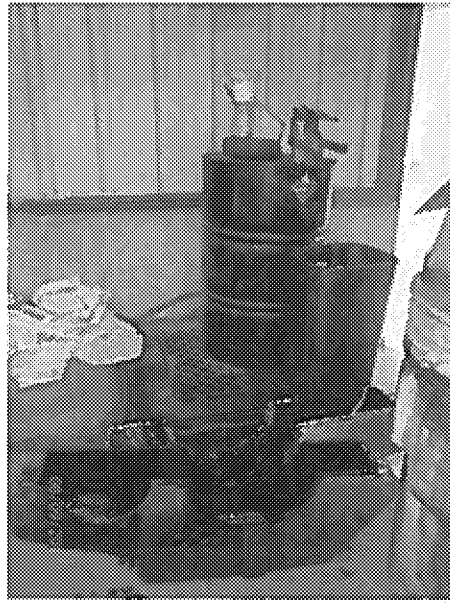
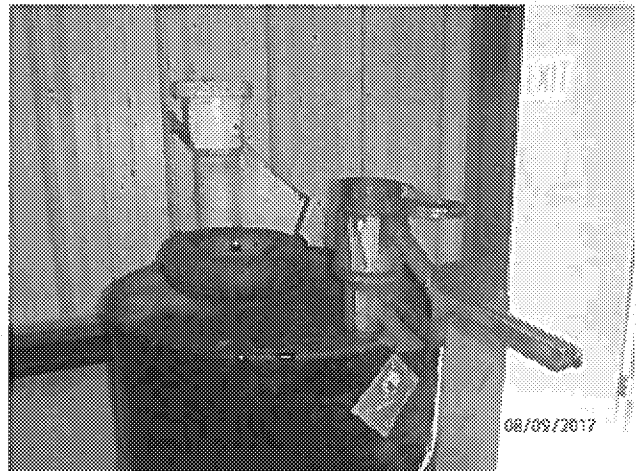
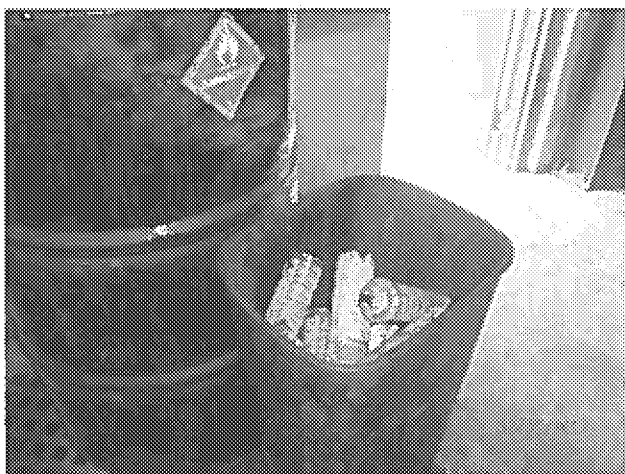
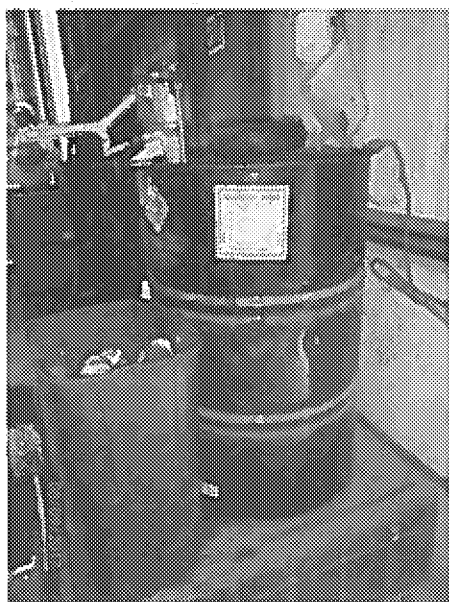
- A Heritage Crystal Clean parts washer with non-hazardous solvent (Picture 29).
- A 55-gallon satellite accumulation drum of spent aerosol can residue with a can puncture system on top (30-33). Next to the aerosol residue drum was a container for the punctured cans. The can puncture system was labeled, not closed and the drum was one-third full. Mr. Salter closed the puncture system lid during the inspection.

Picture 30 --
Locomotive Shop aerosol can puncture drum

Picture 31 -- Locomotive Shop aerosol can puncture drum not closed

Picture 32 -- Locomotive Shop scrap aerosol can container

Picture 33 --
Locomotive Shop aerosol can puncture drum

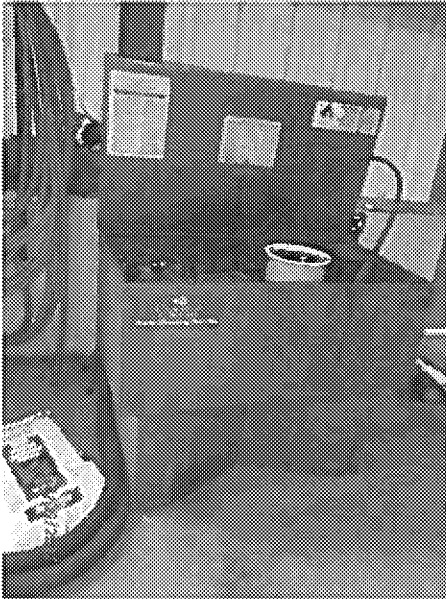
Picture 29 --
Locomotive Shop parts cleaner

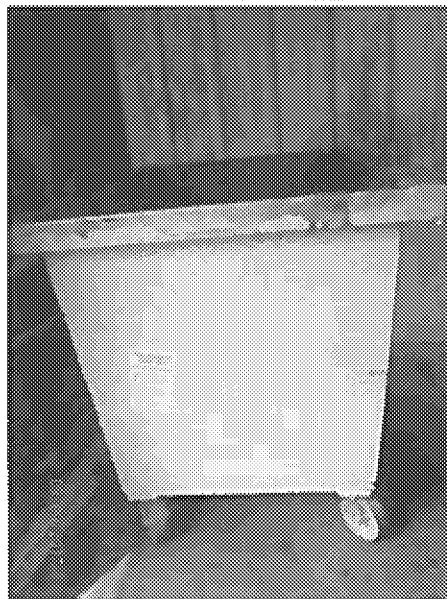
Picture 37 --

- Two yellow totes of used oil and spent diesel, and used oil and used diesel filters (Pictures 34-37, 39-42). One tote was located near the rear of the shop by the door, and the other totes was located in the middle of the shop beside a locomotive. The totes were not closed and had labels but not sufficiently marked as "Used Oil."

Picture 34 --
Locomotive Shop used oil tote not closed

Picture 35 -- Locomotive Shop used oil tote not closed

Picture 36 -- Locomotive Shop used oil tote with filters

Locomotive Shop used oil tote label

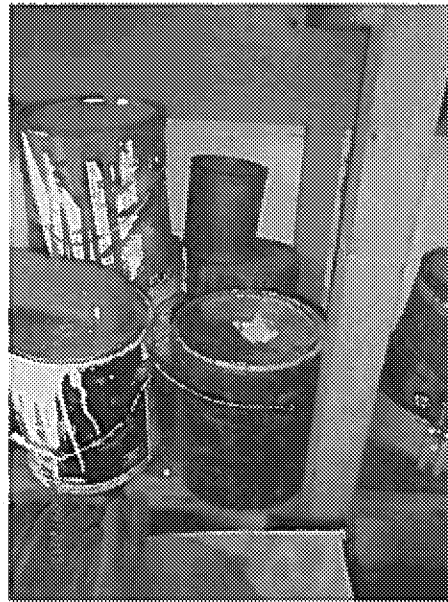
Behind the Locomotive Repair Shop was a storage shed filled with various supplies and equipment. The inspectors observed two one-gallon cans and one pint sized can that were old, rusting and did not have labels (Picture 38). The inspectors stated if the cans were no longer in use, and the facility could not identify the contents of the cans, then waste determination was required prior to disposal of the cans.

Picture 38 --
Storage Shed old paint cans no longer used

Pursuant to ADEM Admin. Code r. 335-14-3-.01(2) [40 C.F.R. § 262.11], a person who generates a solid waste, as defined in ADEM Admin. Code r. 335-14-2-.01(2) [40 C.F.R. § 261.2], must determine if that waste is a hazardous waste following the methods articulated in ADEM Admin. Code r. 335-14-3-.01(2) [40 C.F.R. § 262.11].

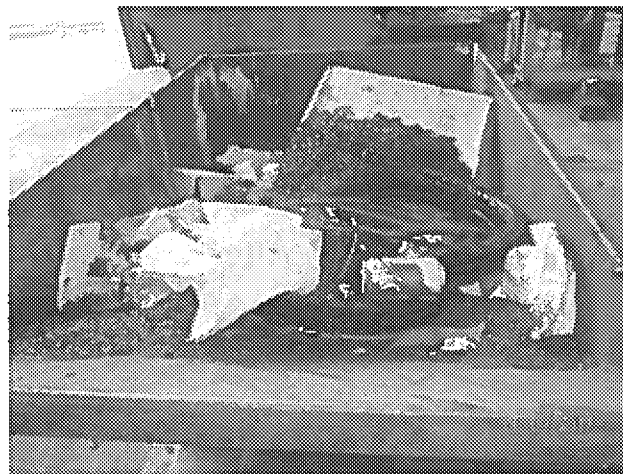
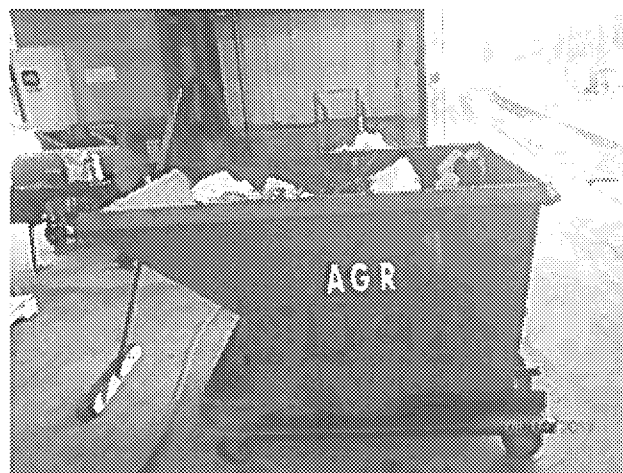
- Three black 55-gallons to be used for oily sludge.
- A metal bin of solid waste and scrap metal (Picture 43-44).
- A metal bin of scrap metal from resurfacing the locomotive wheels (Picture 45).

Picture 43 – Locomotive Shop solid waste and scrap metal

Picture 44 – Locomotive Shop solid waste and scrap metal

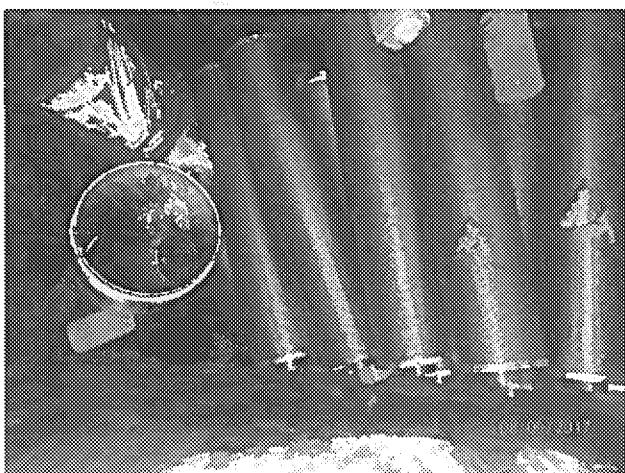
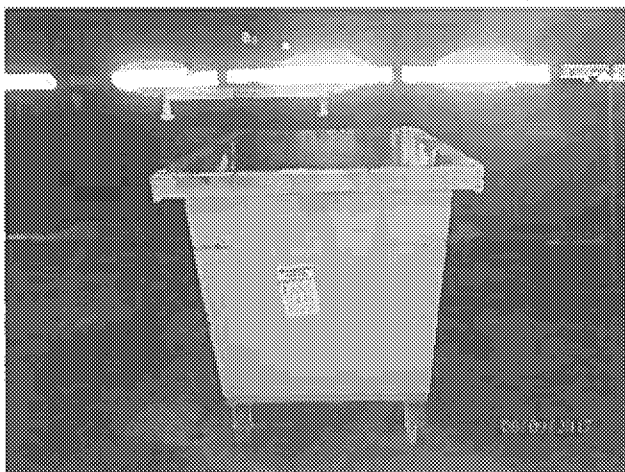
Picture 39 -- Locomotive Shop second used oil tote with filters

Picture 40 – Locomotive Shop second used oil tote with filters

Picture 41 – Locomotive Shop second used oil tote with filters

Picture 42 – Locomotive Shop second used oil tote with label

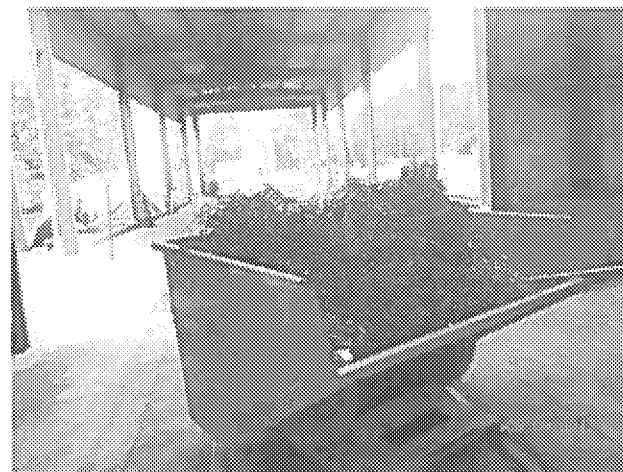
Picture 45 – Wheel Resurfacing scrap metal

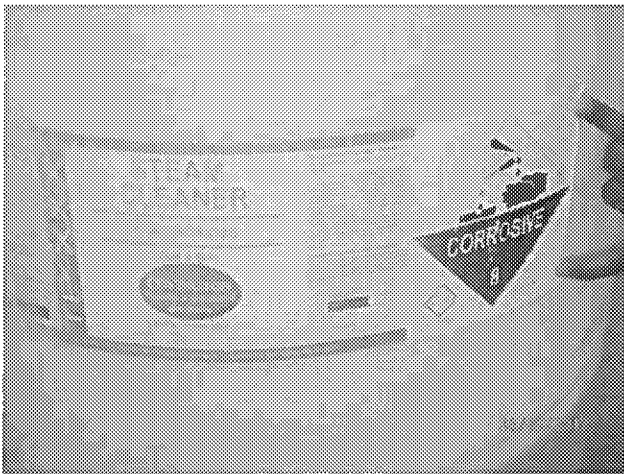
Picture 46 -- Wash Rack Steam Cleaner Concentrate label

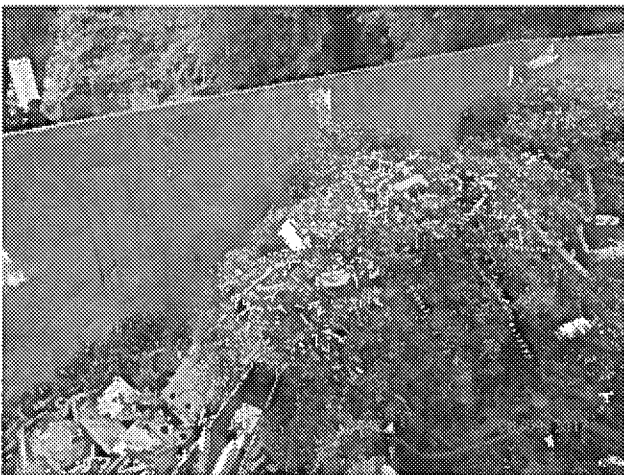
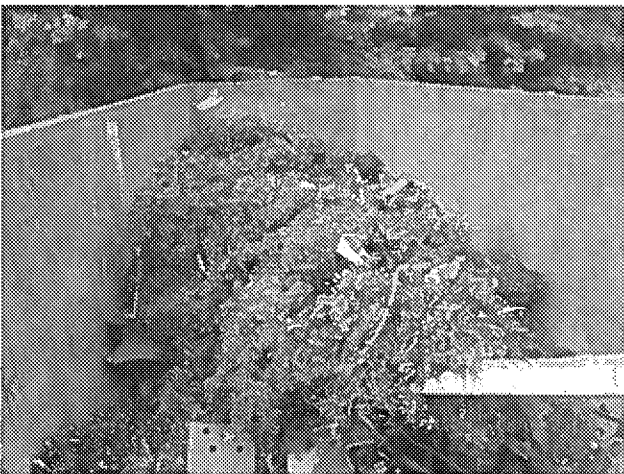
Next to the Engineering yard was a 20-cubic yard roll-off of scrap metal generated from facility (Pictures 47-48). No issues were observed in this area.

Picture 47 -- Scrap Metal Roll-off

Picture 48 -- Scrap Metal Roll-off

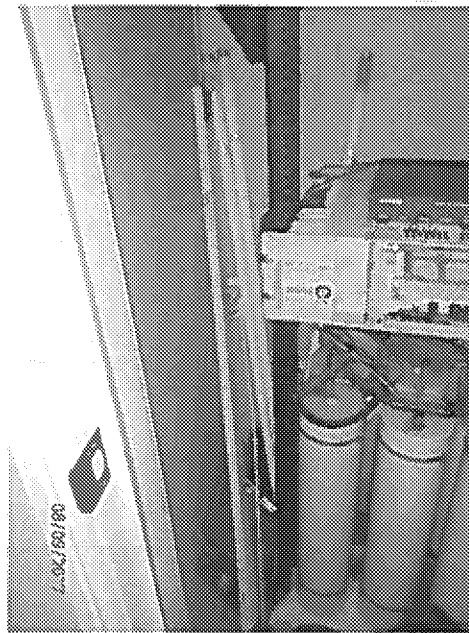
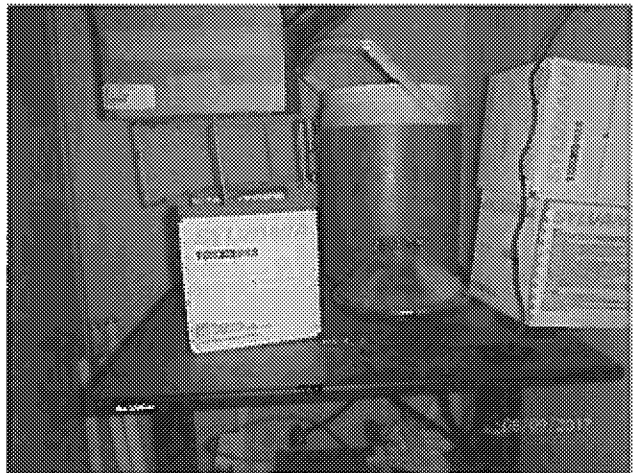
The inspectors observed inside a hall closet four 4-foot fluorescent lamps (Pictures 49-50). The lamps were not contained, labeled or dated. Mr. Salter was not sure if the lamps were usable. The inspectors stated that the lamps should be tested in a fixture to determine if they are spent or usable.

Picture 49 -- Office Closet uncontained fluorescent lamps

Picture 50 -- Office Closet uncontained fluorescent lamps

Pursuant to ADEM Admin. Code r. 335-14-3-.01(2) [40 C.F.R. § 262.11], a person who generates a solid waste, as defined in ADEM Admin. Code r. 335-14-2-.01(2) [40 C.F.R. § 261.2], must determine if broken fluorescent lamps are a hazardous waste following the methods articulated in ADEM Admin. Code r. 335-14-3-.01(2) [40 C.F.R. § 262.11].

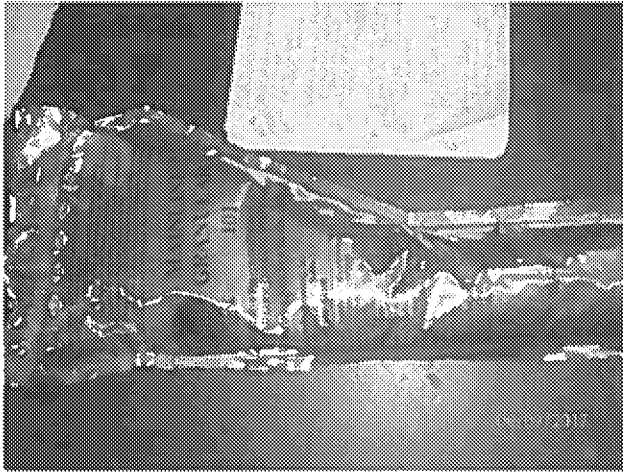
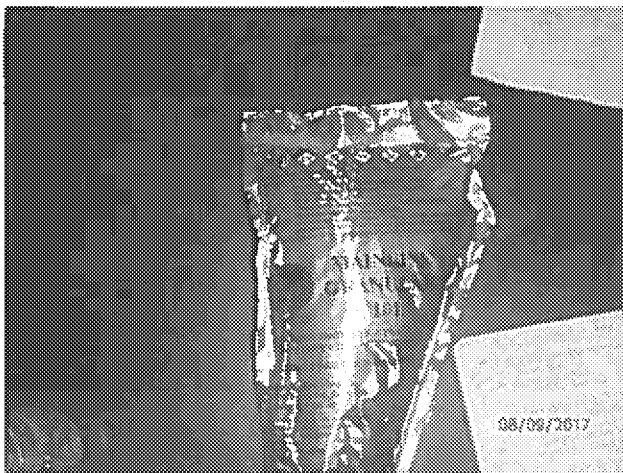
The Locomotive Repair Shop services 28 AGR locomotives as well as 22 additional locomotives for two additional short lines owned by the parent company, Genesee and Wyoming Railroad. The shop provides preventative maintenance for the locomotives such as oil/fuel/air filter changes, 92-day inspections, oil sampling to determine if oil changes are needed, and the addition of Mainline Granular 101, which is a traditional borate/nitrite based cooling water inhibitor specifically designed for closed loop diesel locomotive cooling systems. The Mainline Granular 101 is added to the water tank before adding the solution to the locomotive (Pictures 51-52).

Picture 51 – Mainline Granular 101

Picture 52 – Mainline Granular 101
